Fan Bearing Maintenance & Troubleshooting

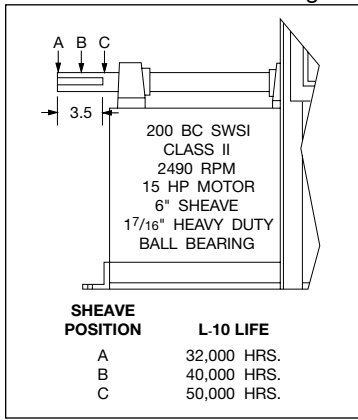
Figure 1 shows a typical fan selected to use a sheave with a six inch diameter on the fan shaft. With the sheave mounted at the end of the shaft, as far away from the bearing as possible, the L-10 life calculates to be 32,000 hours. (See ED-1200 for an explanation of L-10 life.) By moving the sheave 1.25" closer to the bearing, the life is increased to 40,000 hours. When the sheave is moved in another 1.25" so that it is as close to the bearing as possible, the life increases to 50,000 hours. The lesson learned by this example is to maximize bearing life by mounting the sheave as close to the bearing as possible.

Figure 1. Effect of Sheave Location on Bearing Life

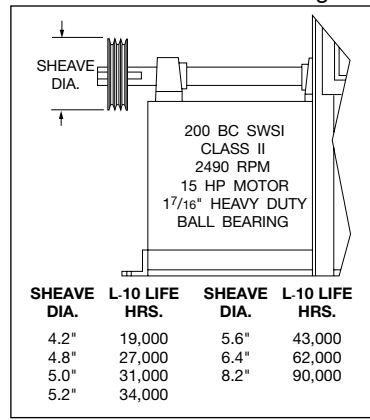
Most belt drives are selected using computer programs. The user puts in the information and the computer selects several sheave and belt combinations that will work, and usually highlights the least expensive. But the combination selected has a significant effect on bearing life. Large sheaves result in less belt pull and longer bearing life. Figure 2 shows the L-10 life for different fan sheave diameters. All of them are viable drive selections. The L-10 life varies from 19,000 hours with a 4.2 inch diameter sheave, to 90,000 hours with an 8.2 inch diameter sheave. Avoid the selections with the smallest sheave sizes. They are probably not the least expensive anyway since they require more belts. The best drive selection is one with a reasonable sheave size and moderate cost.

Figure 2. Effect of Sheave Diameter on Bearing Life

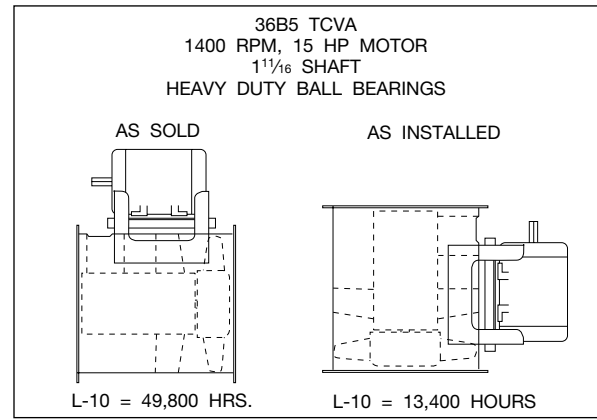
Fan orientation affects bearing life. A fan designed to operate with its shaft positioned horizontally will have a lower bearing life when positioned with a vertical shaft. This is due to the additional thrust loads put on the bearings from the shaft and impeller weight. Figure 3 shows an example. An axial fan designed for horizontal duty has an L-10 life of 49,800 hours. Tipping the fan so that the shaft is vertical lowers the bearing life to an unacceptable level of 13,400 hours. If a fan is to operate with a vertical shaft, make sure to order it for this orientation.

Figure 3. Effect of Shaft Position on Bearing Life

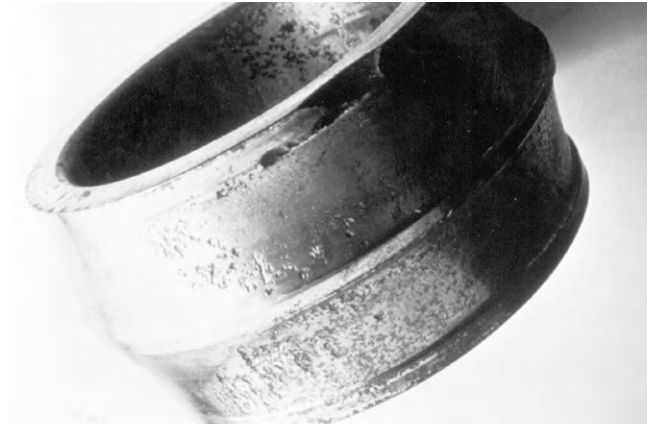
Figure 5 shows an inner race that has had a normal fatigue failure. The repeated loading and unloading of the race every time a roller passes eventually causes microscopic fatigue cracks to form under the surface.

In time, these cracks grow to the point where small portions of the surface flake off. This process is called "spalling" and the flaws left in the surface are called "spalls."

Figure 5. Normal Fatigue Failure

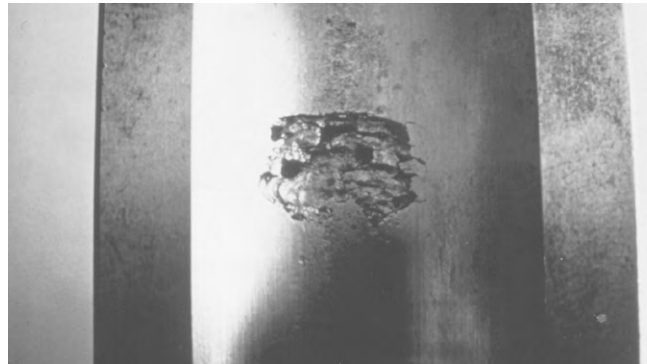
With continued operation, the spalls grow until the bearing becomes noticeably noisy. Figure 6 shows an inner race that has a severe spall. In addition to being noisy, it is also likely that this bearing would show high levels of vibration. The time required for the spalling to cause catastrophic bearing failure will vary with the load on the bearing and its speed. Usually the bearing will run for a while after it becomes noisy, but once noise is heard, prepare to have the bearing changed before it fails suddenly.

Figure 6. Spall

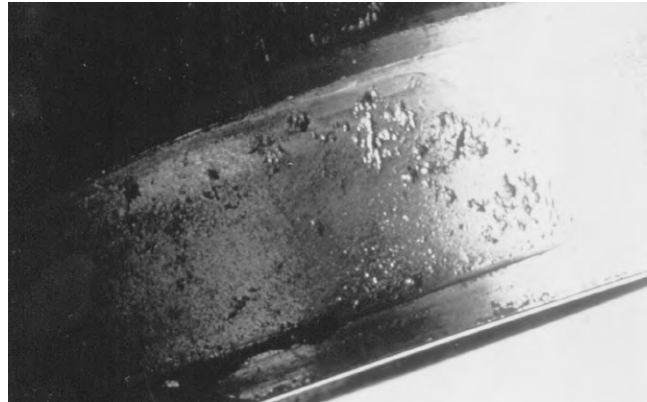
Inadequate lubrication can lead to spalling as seen in Figure 7. This bearing also shows signs of excessive

Figure 7. Spalls & Wear Patterns in the Race

wear due to inadequate lubrication. The rollers have worn a very deep wear pattern in the race.

Material that flakes out of spalls and other contaminants from other sources such as dirty grease or worn seals dents the races when caught between the rollers and races. Figure 13 shows an inner race with severe particle denting. Figure 7 also shows signs of particle denting. Each dent is a stress concentrator, which increases the stress in the area around the dent and accelerates the fatigue failure process.

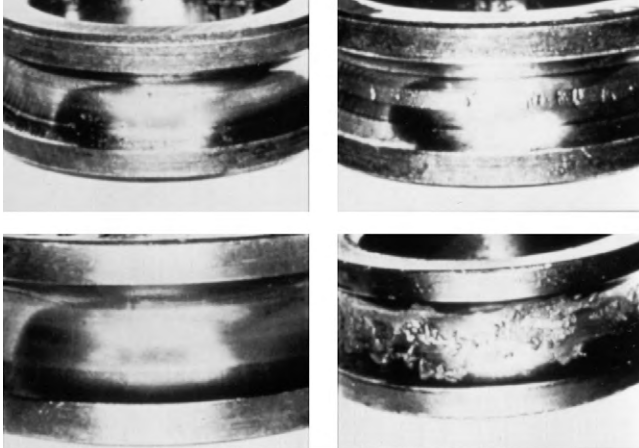
Figure 8 shows the progressive failure of a bearing due to inadequate lubrication. At first there are traces of waviness, or a slight roughening of the race. With time small cracks develop, which lead to a modest amount of spalls and eventually the severe amount of spalling shown on the lower right.

Figure 8. Progressive Failure of a Bearing Due to Inadequate Lubrication

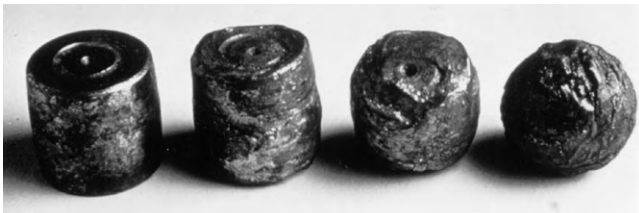
If the bearings continue to operate with inadequate lubrication, the evidence that shows this to be the mode of failure becomes destroyed. Notice how the spherical bearing rollers shown in Figure 9 become damaged with continued operation.

Figure 9. Damaged Spherical Bearing Rollers

If the bearing had been taken out of operation when the roller was in the condition shown on the left, it would be possible to determine the cause of failure. By the time the bearing completely failed, it had run so hot that the steel softened and the bearing became deformed. At this point it is impossible to tell what caused the initial failure. If you are having unexplained bearing failures, it is best to take the bearing out of service when you first notice noisy, hot or vibrating operation. The evidence showing the initial cause of failure is probably still visible, and it will give you an idea as to what action to take to prevent additional failures.

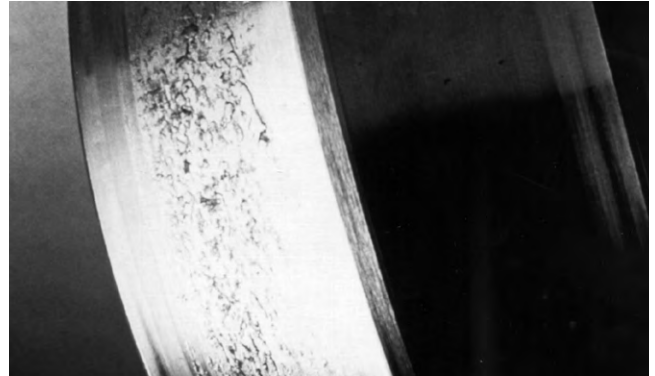
Under the right conditions the heat generated by metal-to-metal contact causes the two surfaces to adhere for an instant. Small portions tear out from one surface and adhere to the other surface. This is "smearing" and is shown in Figure 10.

Figure 10. Smearing

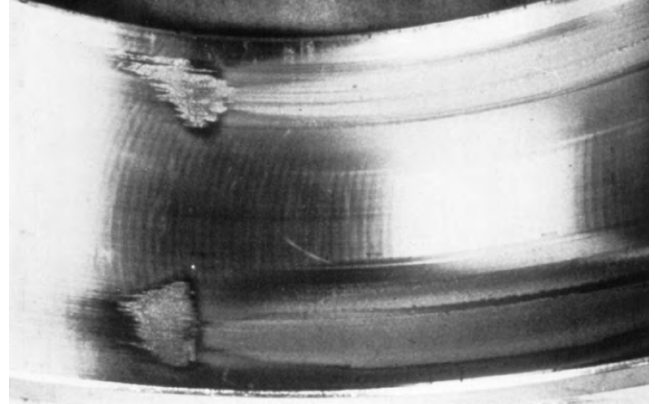
"Skid smearing," shown in Figure 11, occurs on lightly loaded bearings. As the rollers come around and enter the lower half of the bearing, they go from being

Figure 11. Skid Smearing

unloaded to being under load. With the light load it takes them some distance to roll properly, and they skid against the race causing smearing.

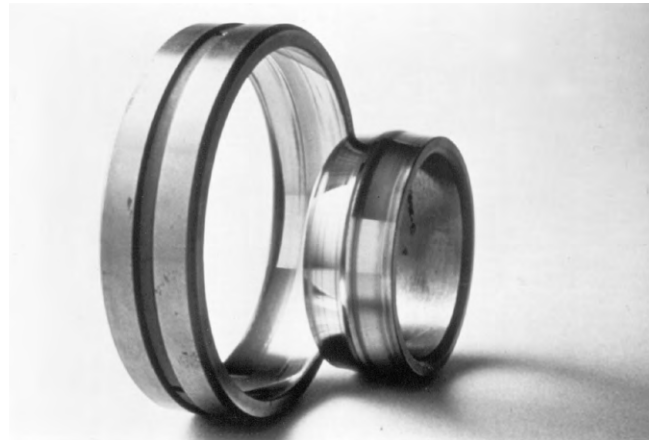
Figure 12. Highly Polished Surfaces Due to Inadequate Lubrication

Inadequate lubrication can sometimes cause the bearing surfaces to become highly polished as Figure 12 shows. Even though the surface looks nice, this is an indication of trouble. With continued operation the surface will change to a frosty appearance and eventually spall.

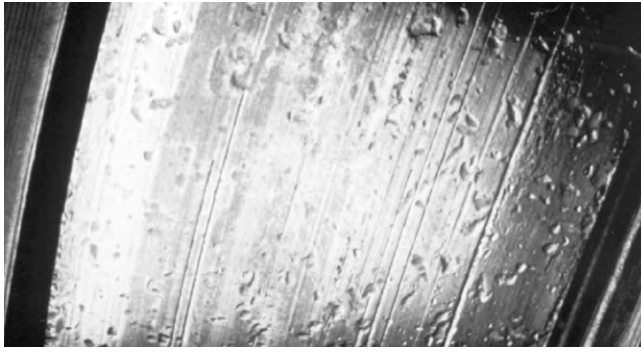
Figure 13. Severe Particle Denting

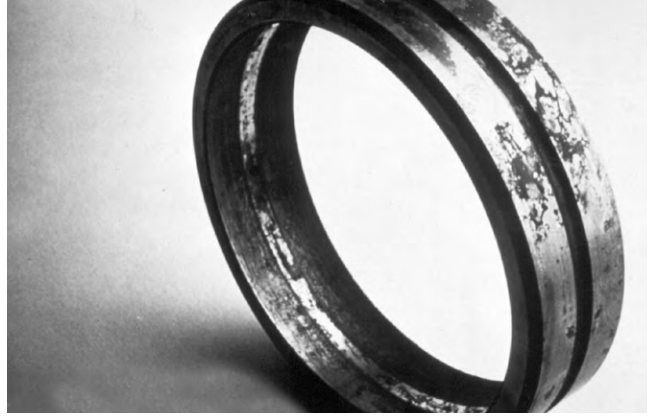
Keeping moisture out of bearings is necessary to achieve long life. Figure 14 shows a bearing severely damaged from water corrosion. This much damage was

probably due to seal failure, possibly in a “wash down” environment. High moisture applications require the use of grease that has rust inhibiting properties. Frequent relubrication is necessary, to insure that all bearing surfaces are coated with a protective layer of grease and that the rust inhibitors are replenished. Figure 15 shows a spherical roller bearing roller that has rusty ends from moisture in the lubricant.

Figure 14. Water Corrosion

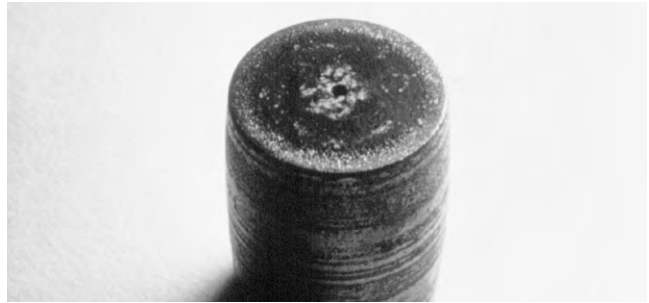
Figure 15. Bearing Roller with Rusty Ends Due to Moisture in the Lubricant

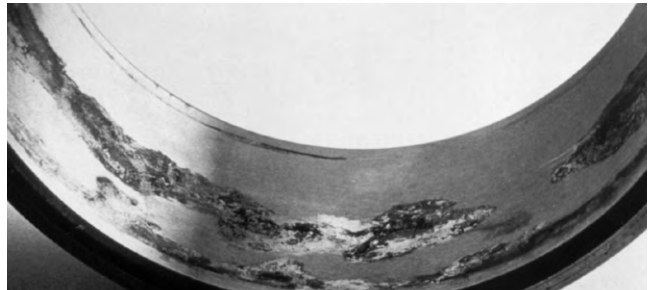
Water from condensation causes corrosion in idle fans. This is particularly true for fans in high moisture areas, located outdoors, or improperly stored outdoors. Figure 16 shows an outer race damaged by puddle corrosion. Moisture or dew condensing in the bearing settles to the bottom of the race in puddles and causes rusting. Twin City Fan Companies packs ball and unit roller bearings completely full of grease prior to shipment. Split pillow block spherical roller bearings are shipped with the bearing insert packed full. This minimizes the chances of having puddle corrosion occur during shipment and storage. This practice covers all components with grease, and insures there are no pockets of air where water can condense. At startup the excess grease purges out of the bearing, which gets a little messy but is better than having a damaged bearing.

Figure 16. Puddle Corrosion

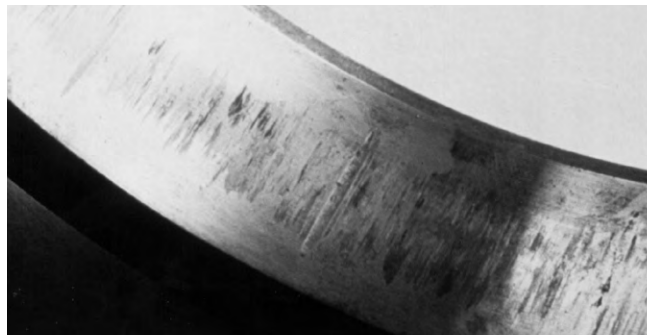
Figure 17 shows damage to an outer race from a bearing subjected to vibration while the unit is not rotating. Notice the even spacing of the marks, which correspond to the roller spacing. You can also see marks where the rollers came to rest in different locations. This type of damage, called “false brinnelling,” occurs when small portions of the race get rubbed away. The remaining area is ideal for starting fatigue, and the abrasive material rubbed off contaminates the grease which accelerates bearing wear.

Figure 17. False Brinnelling

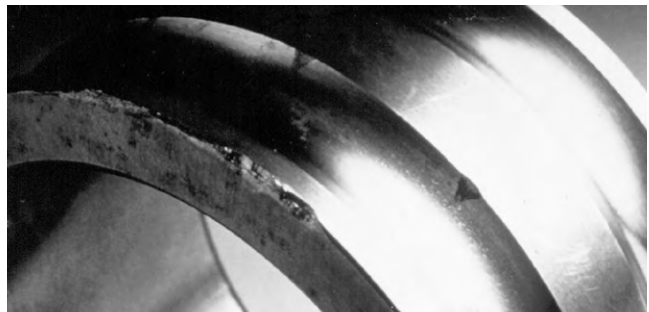
“True brinnelling” occurs when a bearing is subjected to impact and the rollers dent the races. Figures 18 and 19 show damage caused by improper mounting. Impact from hammering on the outer race or the bearing housing causes true brinnelling of the races. If it is necessary to tap on a bearing to get it into position, tap on the inner race so that the rolling elements do not carry the load. Dropping a bearing prior to mounting can also cause true brinnelling. Like false brinnelling, the marks are evenly spaced and the damage will eventually develop into spalls. Figure 20 shows spalls resulting from true brinnelling.

Figure 18. True Brinnelling

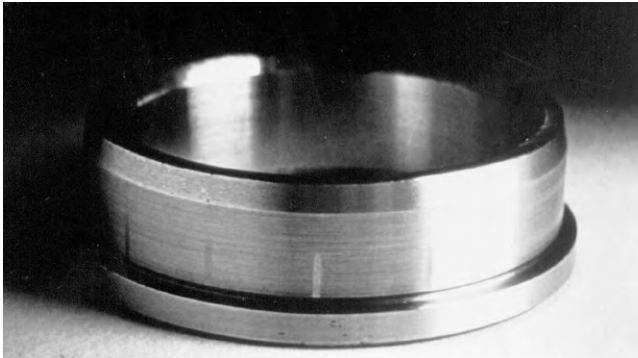
Figure 19. True Brinneling

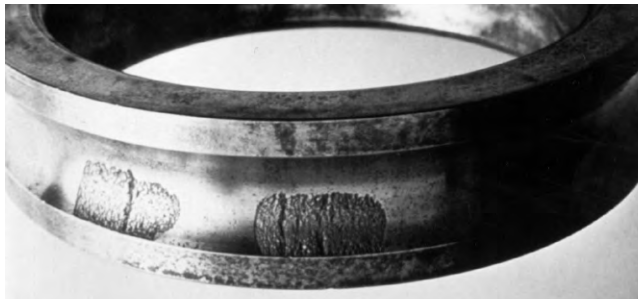
Figure 20. Spalls Resulting from True Brinneling

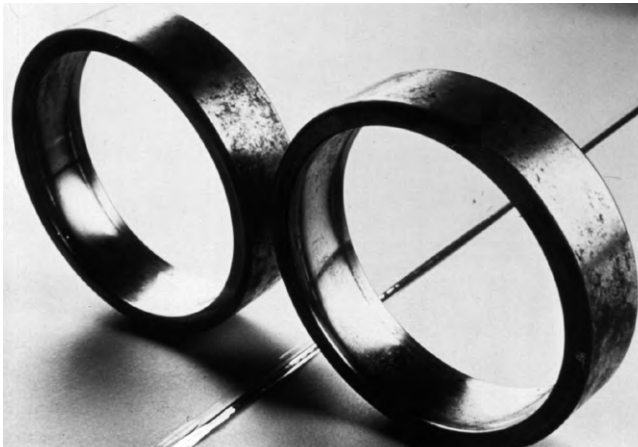
Mounting a bearing pillow block on a warped or crowned surface, or improperly shimming a pillow block can pinch the outer race. As seen in Figure 21, this causes two load zones on the outer race 180° apart.

As the rolling elements pass through the pinched area, the load between them and the races increases. If the severity of the pinch is high, a drastic reduction in the life of the bearing will result.

Figure 21. Two Load Zones on the Outer Race

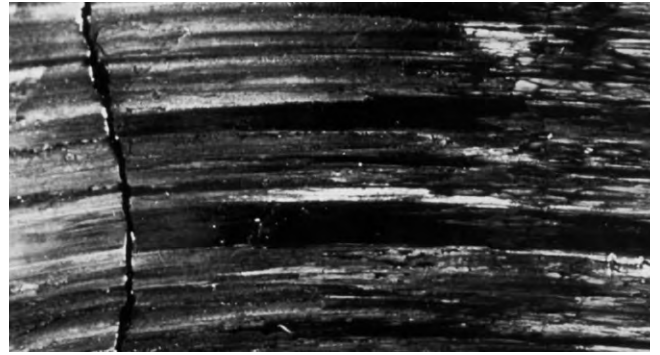
failures. Figure 22 shows the surface of a bearing bore that had too much clearance. The shaft turned in the bore, smearing the surface.

Insufficient tightening of the setscrews on a setscrew mounted bearing causes this type of failure. It can also be caused on a tapered adapter mounted bearing by not tightening the adapter lock nut enough. The damage to the surface resulted in a crack.

Figure 22. Smearing on a Bearing Race

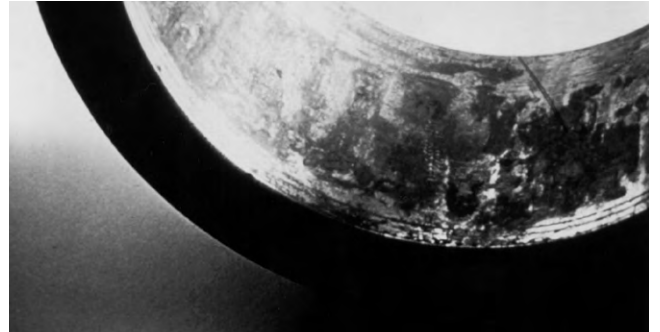
The bore of the bearing shown in Figure 23 shows signs of serious fretting corrosion. Microscopic movement between the shaft and the bore causes the rust colored patches to develop. Small amounts of fretting are common with setscrew mounted bearings and are not detrimental to bearing life. Advanced cases, caused by loose mounting, can lead to cracks.

Figure 23. Fretting Corrosion on Bearing Bore

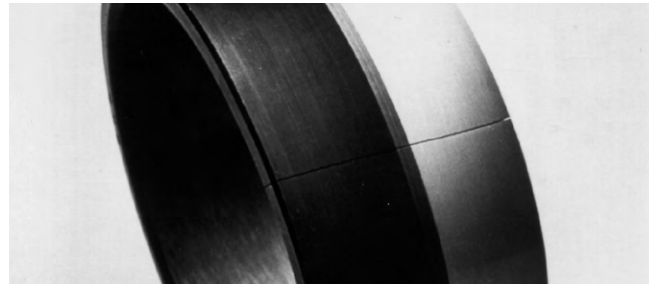
Tightening the locknut of an adapter mounted bearing too much can crack the inner race as shown in Figure 24, or the outer race as shown in Figure 25.

Figure 24. Cracked Inner Race

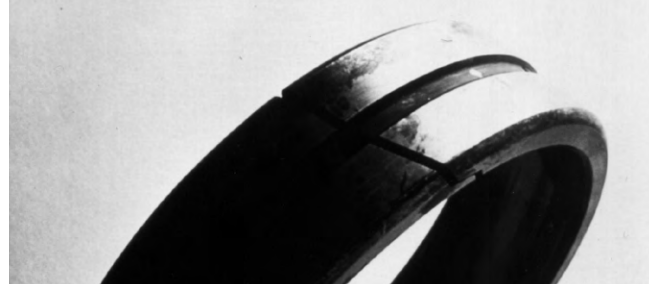
This also occurs by exposing the bearing on a high temperature fan to excessive temperatures. This easily happens when shutting down high temperature fans when they are hot, or by exposing them to high temperatures while idle.

Figure 25. Cracked Outer Race

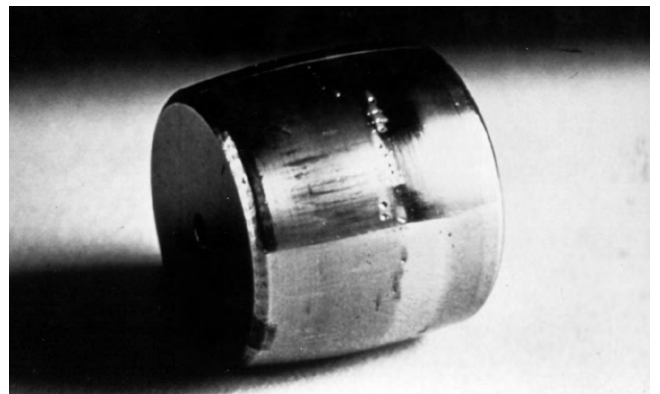
Figure 26. Pits Caused by Electrical Current

Allowing electrical current to pass through a bearing can cause damage. Figure 26 shows a spherical roller with pits in its surface caused by electrical current. This type of damage commonly occurs when welding balance weights on a fan wheel with improper grounding. To avoid having the welding electrical current pass through the bearings, attach the grounding clamp to the wheel or shaft when adding balance weights.
