Variable Frequency Drive (VFD) Induced AC Motor Shaft Current and Bearing Damage

TWIN CITY FAN & BLOWER | WWW.TCF.COM

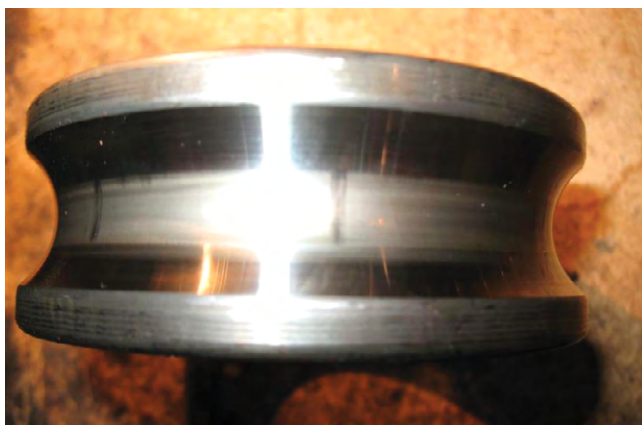
Figure 2. Bearing race exhibiting a "frosted" appearance.

In cases where induced shaft voltage exceeds the dielectric resistance of the bearing lubrication film, electric current will arc from the bearing ball or roller and raceway with sufficient amperage to create EDM pit. Due to the high frequency of the switching circuits, the electrical discharge arcs through the bearings can also occur at a high frequency. Even after a short period of time, the entire bearing race will become coated with small EDM pits. The inside surface of the bearing race will take on a "frosted" appearance. Eventually the bearing race will become severely pitted and fluted. Excessive noise and eventual bearing failure are the end results. Motor bearing failures have been documented after as little as a few months of operation. The majority of motor bearings that experience this issue will fail after 3 to 12 months of operation.

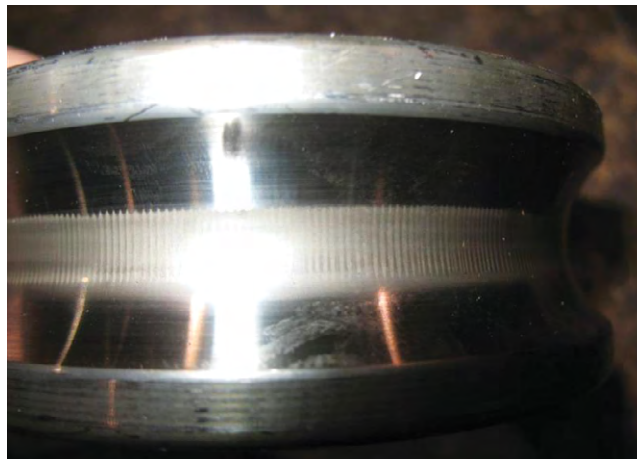
Figure 3. Bearing race exhibiting "fluting".
